SIK PEITZ

Starting Position:

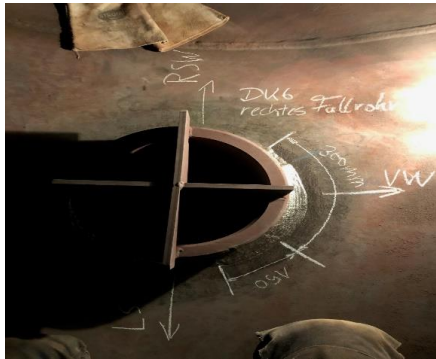
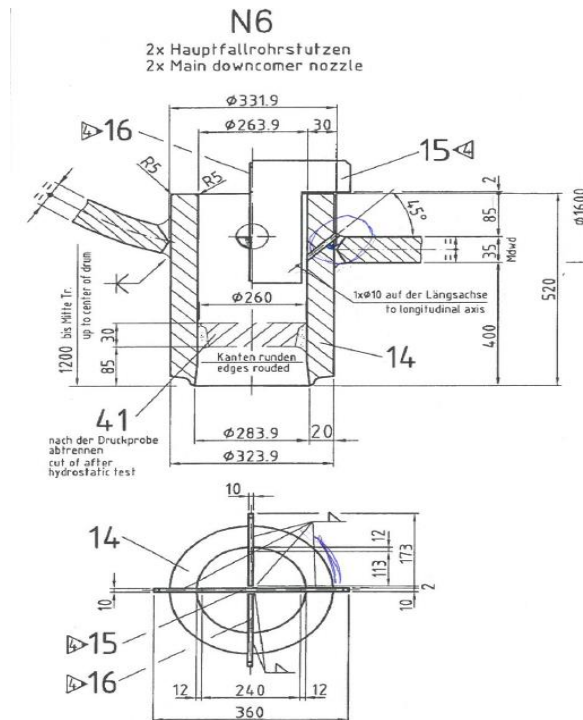
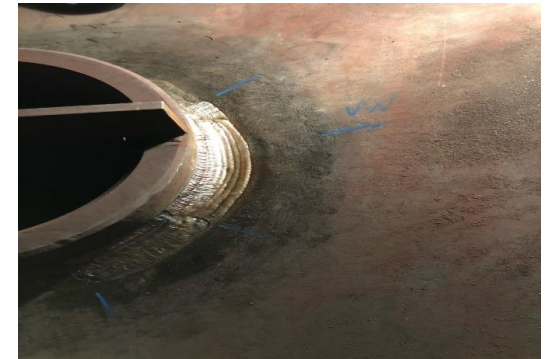
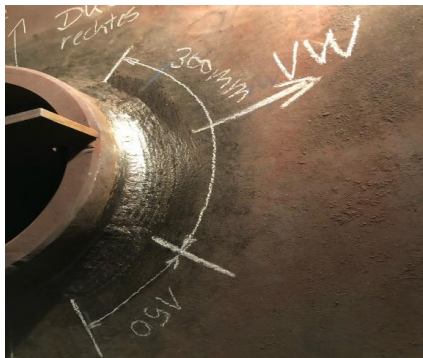
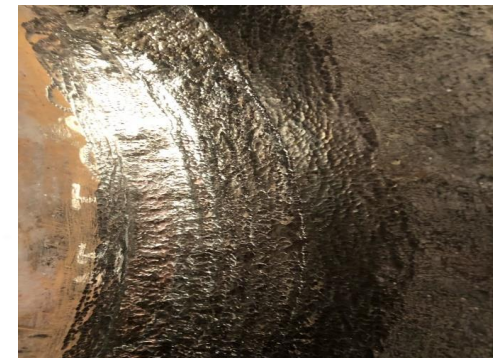
„Cracks repeatedly occurred at the (weld) seam of the downpipe socket in a power plant, which reappeared even after repair.“

„After one year of operation, the drum was inspected again and no damage was found in the repair area.“

Then followed a PIT treatment of the repair seams:
